Manhole Inspection Summary

Manhole # S71O__020MH

Insp Date: **4/21/08 10:36 AM**

Location Address: **6736 Youngstown Ave.**

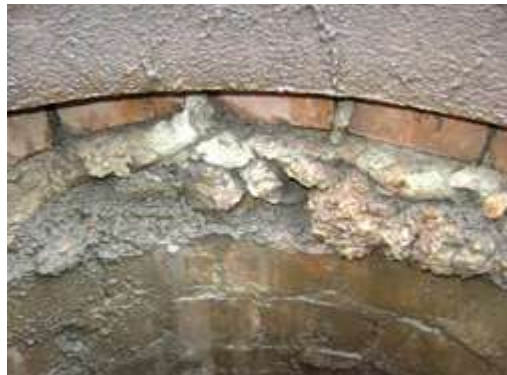
Defect 1

Condition: ☐ Sound ☐ Cracked ☐ Root Intrusion ☒ **Loose Brick** ☐ Deteriorated

Infiltration: ☐ None ☒ **Joint** ☐ Cracks ☒ **Mortar** ☐ Roots ☐ Wall

loose bricks and cracked mortar under frame seal

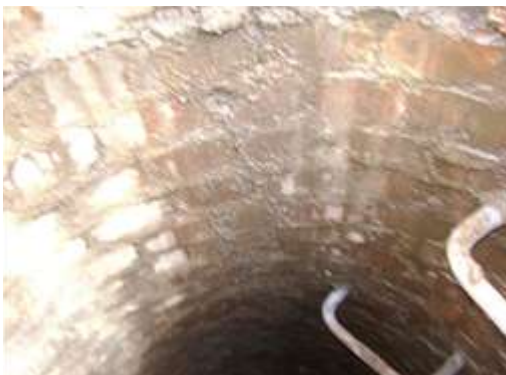
Defect 2

Infiltration: ☐ None ☒ **Joint** ☐ Cracks ☒ **Mortar** ☐ Roots ☒ **Wall**

infiltration on barrel wall

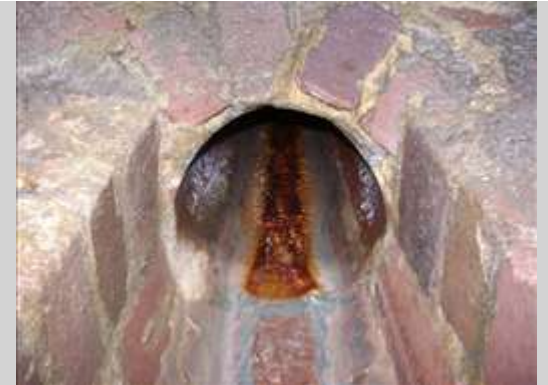
12 O'Clock Outflow

Pipe Height: **8.4** (in.) Rod and Bar (Angled)
Pipe Material: **Clay** ☐ Pipe Lined
Invert Depth: **9.25** (ft.) Flow Characteristics: **Slow**
Deposits: ☒ None ☐ Mud ☐ Sludge ☐ Debris ☐ Grease
Silt Depth: (in.) Deposits Extent:
Infiltration: **None** Pipe Seal Cond: **Sound**

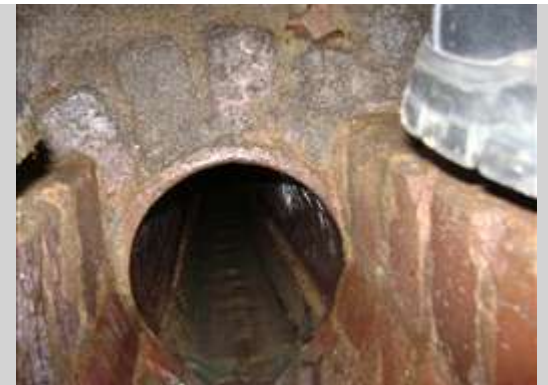
6 O'Clock Inflow

Pipe Height: **8.4** (in.) Rod and Bar (Angled)
Pipe Material: **Clay** ☐ Pipe Lined
Invert Depth: **9.13** (ft.) Flow Characteristics: **Slow**
Deposits: ☒ None ☐ Mud ☐ Sludge ☐ Debris ☐ Grease
Silt Depth: (in.) Deposits Extent:
Infiltration: **None** Pipe Seal Cond: **Sound**
